# HAGAR TOWNSHIP

Park Development Plan and Recommendations for Beach & Bluff Stabilization

ABONMARCHE CONSULTANTS, INC.
95 W. MAIN
BENTON HARBOR, MICHIGAN

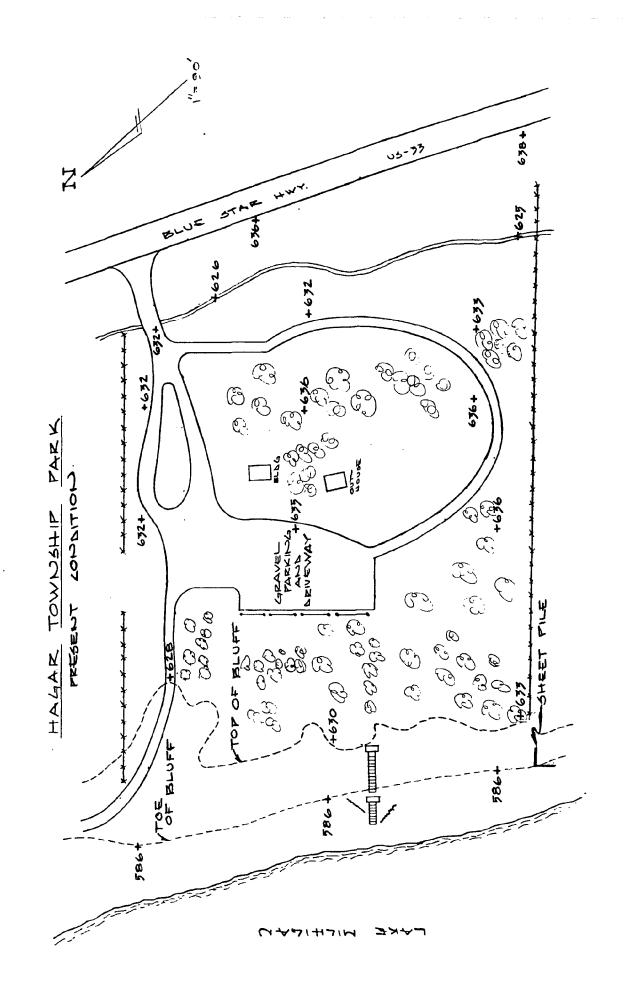
WATER ELEV. @ TIME OF SURVEY 979.1 (7/1/81)

With the exception of the lake bluff, creek ravine, and pedestrian walkway, the park site is comparatively level. The south central area of the park forms a slight rise of about 3' over the surrounding area. The northern boundary is about 4' lower than the access road. The lake bluff is about 45' above the beach and presents a fairly precipitous face. The bluff is the dominant topographic feature of the site, providing an excellent view while also posing serious erosion and safety problems. The bluff will be dealt with in considerable detail in the section "Recommendations For Beach And Bluff Stabilization Of Hagar Township Park".

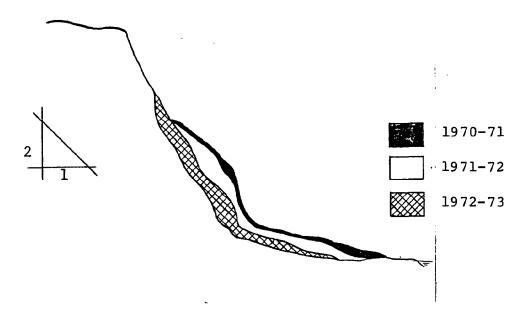
The Hagar Township Park is located in an area of fairly high bluffs of glacial drift. The bluffs rise about 40 feet above lake level and have in the past decade receded as a result of periods of high lake levels and storms. During a three-year period (1970-1973) net annual changes in beach and bluff profiles were recorded by Davis (Reference 1). These profiles are reproduced below to demonstrate the erosion problems at this site.

The beach width of Hagar Township Park has fluctuated considerably. This is in part a result of water level fluctuations of the lake, and in part due to erosion and accretion of the beach itself.
